MHT No. <u>PG: 65-23</u>

# MARYLAND INVENTORY OF HISTORIC BRIDGES HISTORIC BRIDGE INVENTORY MARYLAND STATE HIGHWAY ADMINISTRATION/ MARYLAND HISTORICAL TRUST

SHA Bridge No	<b>16065</b>	_Bridge name <u>MD</u>	320 (Piney Branch	Road) ove	r Northwes	t Branch
<u>LOCATION:</u> Street/Road na	me and nu	mber [facility carrie	ed] <u>MD 320 (Pine</u>	y Branch F	Road)	
City/town	Takoma Pa	rk		_Vicinity _	X	
County Pr	ince Georg	e's				
This bridge pro	ojects over:	Road Raily	way W	'ater <u>X</u>	L	and
Ownership: St	ate X	County	Municipa	ıl	Other _	
Nationa	cated with al Register-	n a designated histo listed district district	National Registe	r-determin	ed-eligible	district
Name of distri	ct					
BRIDGE TYPE Timber Bridge Beam B	:	Truss -Cover	ed Trestle	Timb	er-And-Coi	ncrete
Stone Arch Bri	dge					
Metal Truss B	ridge	<u></u>				
	e:   Lift		Single Leaf le		Iultiple Lea	
	Girder irder	Rolled G	irder Concrete Enc rder Concrete Enca			
Metal Suspens	ion					
Metal Arch						
Metal Cantilev	er					
Concrete	X: te ArchX	Concrete Slab	Concrete B	eam	Rigid Frai	ne
Other	Type Na	ame				<del></del>

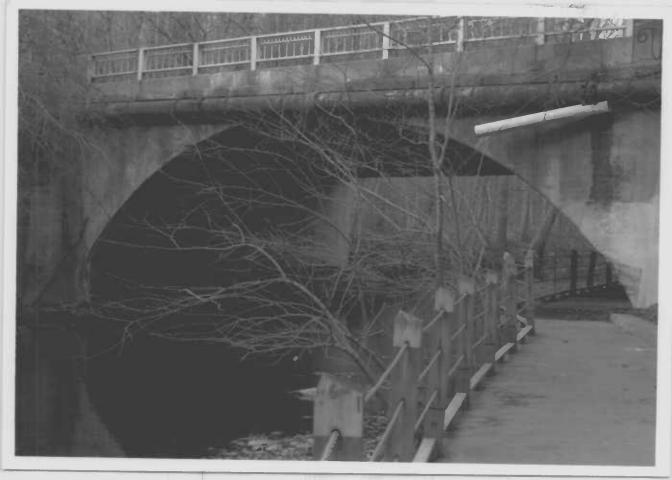
8. 1 of 4

5. 12/97
6. MD SHPO
7. Elevation looking upstream

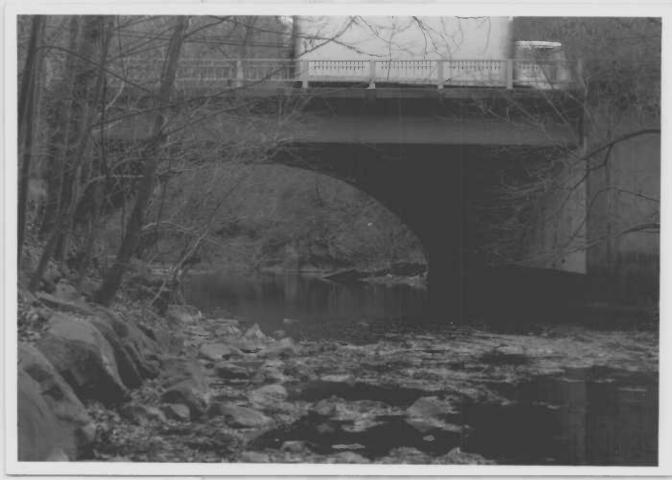
- 1. PG:65-23
- 2. MD 320 over Northwest Branch
- 3. Prince George's Co., MD
- 4. Wallace, Montgomery & Assoc.
- 5. 12/97
- 6, MD SHPO
- 7. Elevation looking downstream
- 8. 2 of 4

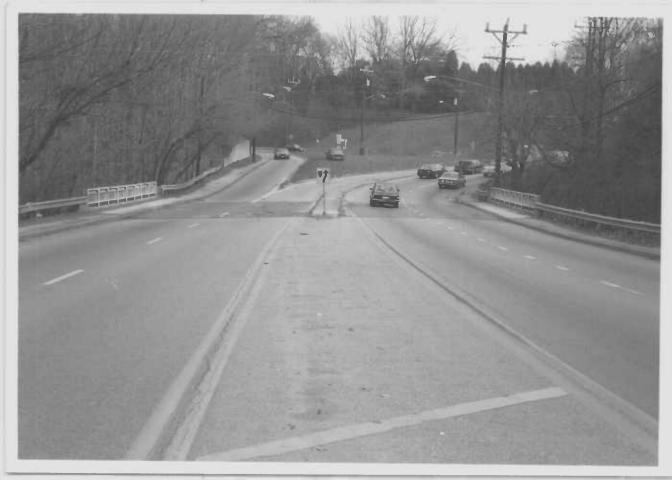
- 1. PG:65-23
- 2. MD 320 over Northwest Branch
- 3. Prince George's Co., MD
- 4 Wallace, Montgomery & Assoc,
- 5. 12/97
- 6. MD SHPO
- 1. Looking East
- 8. 30 + 4

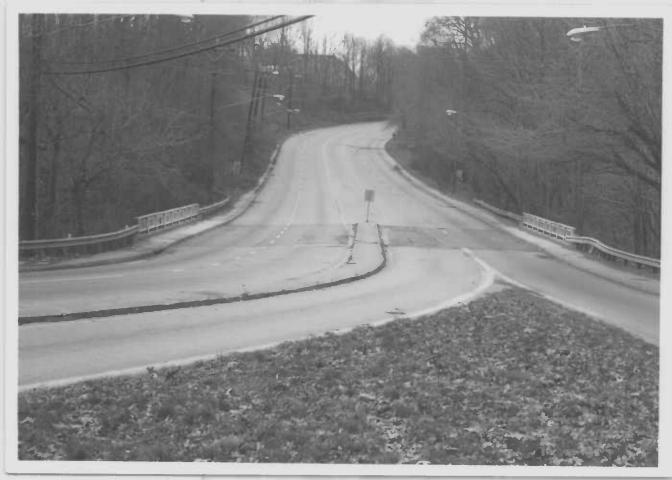
- 1. PG:65-23
  2. MD 320 over Northwest Branch
  3. Prince George's Co., MD
- 4. Wallace, Montgomery & Assoc, 5. 12/97
- 6. MD SHPO
- 7. Looking West
- 8, 4 of 4
